Subject: Vibration Impact Assessment
Tie Line 649 Wood to Steel Replacement Project
San Diego Gas & Electric Company
San Diego County, California
AECOM Reference No. 60597643

Photo Documentation
San Diego Gas and Electric - TL 649 Vibration Assessment
Chula Vista, California

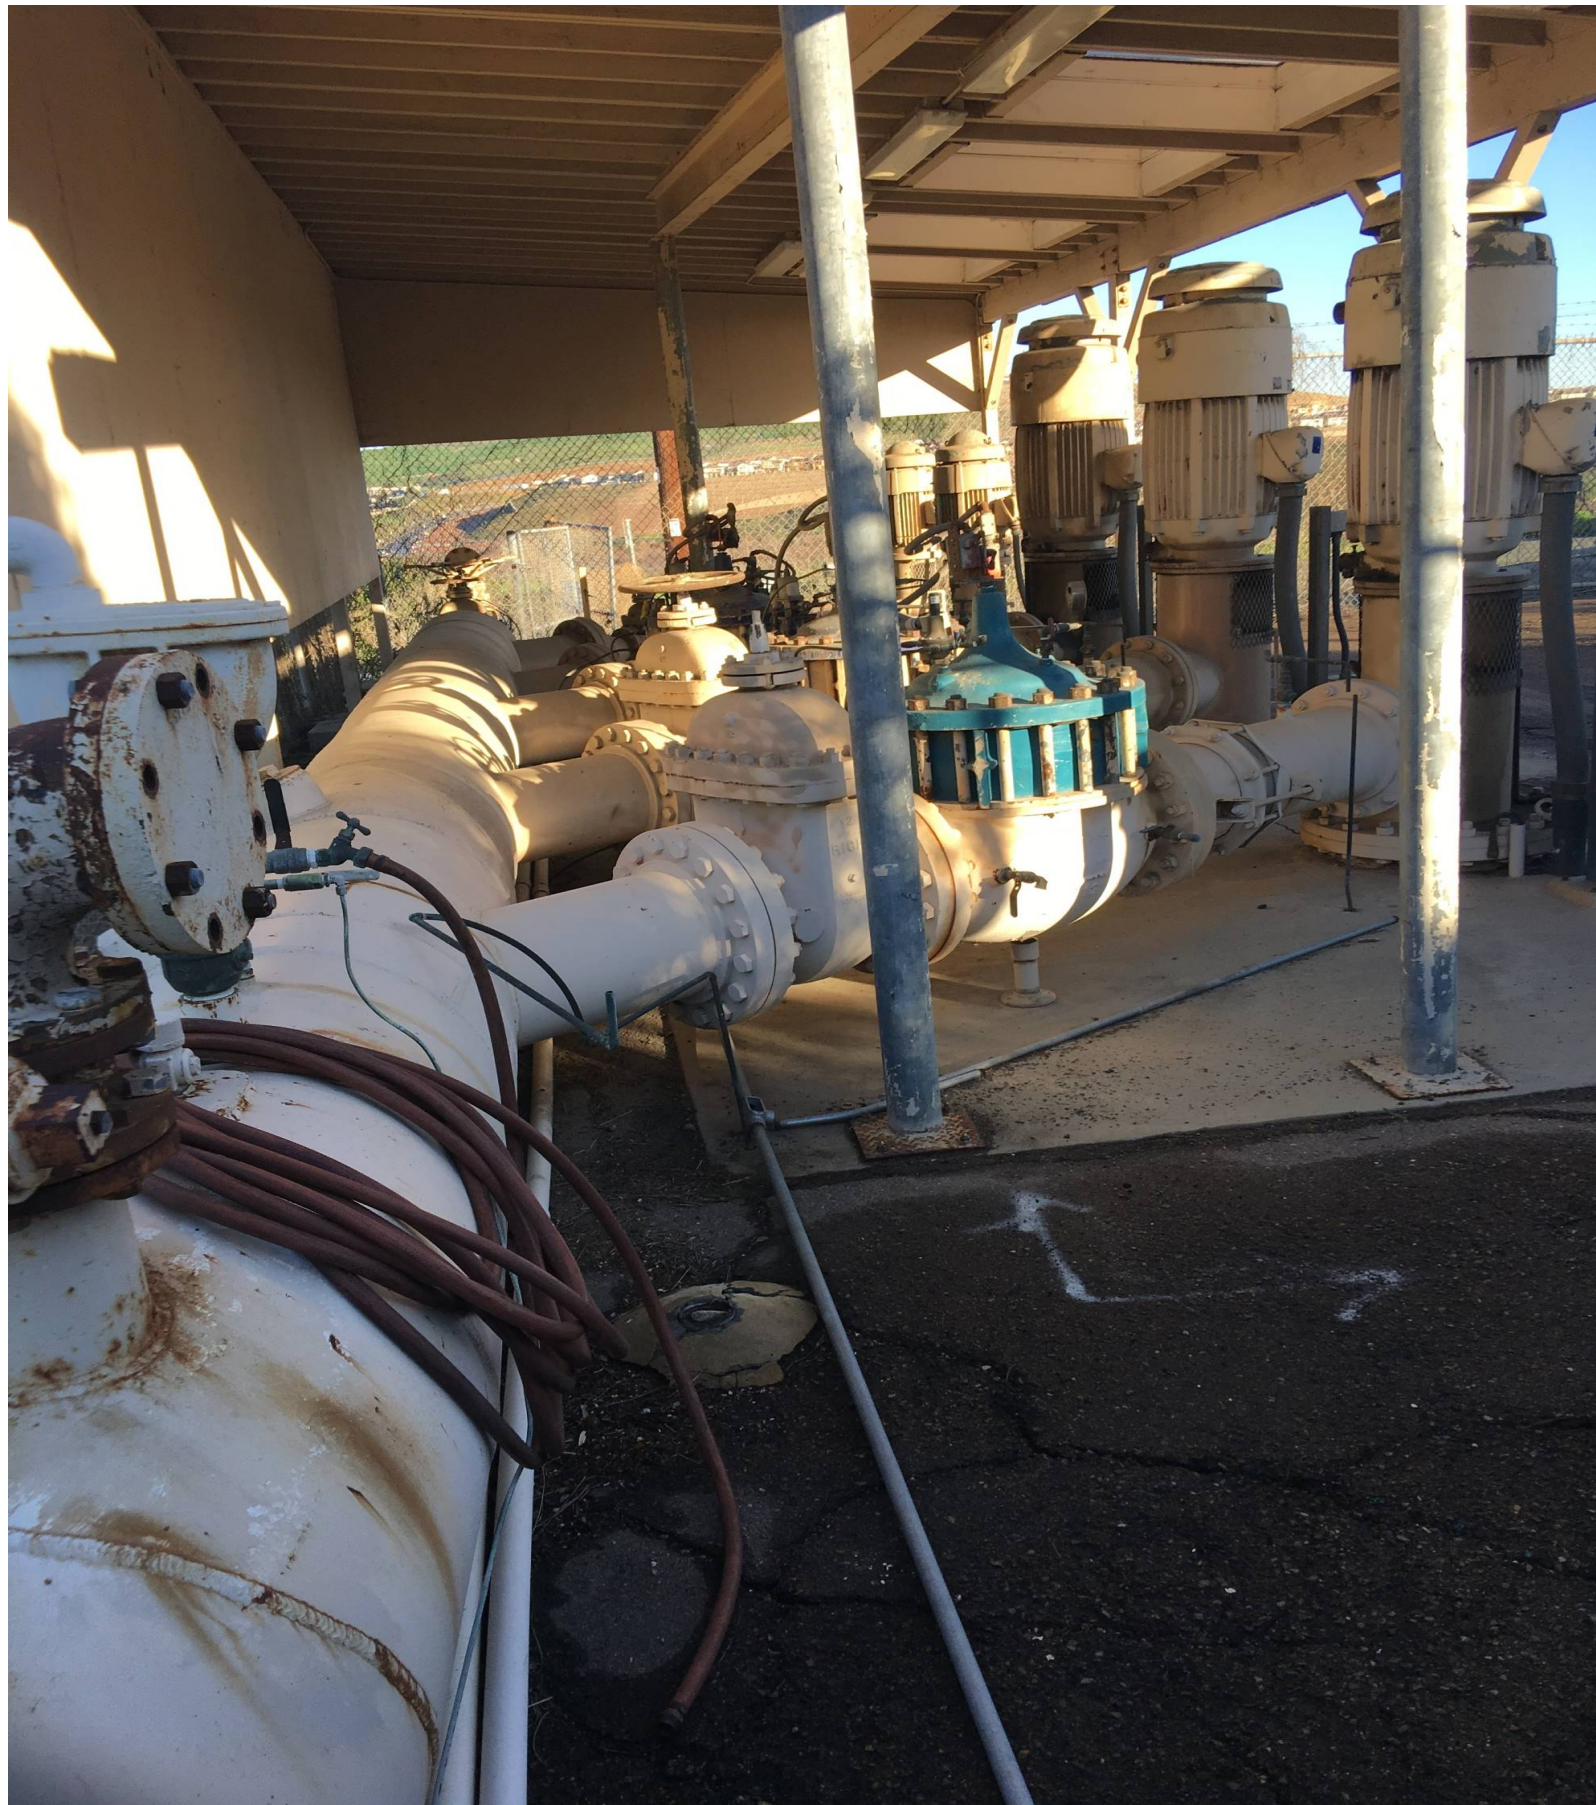
Pipes and pumps looking west near Pole 18.1

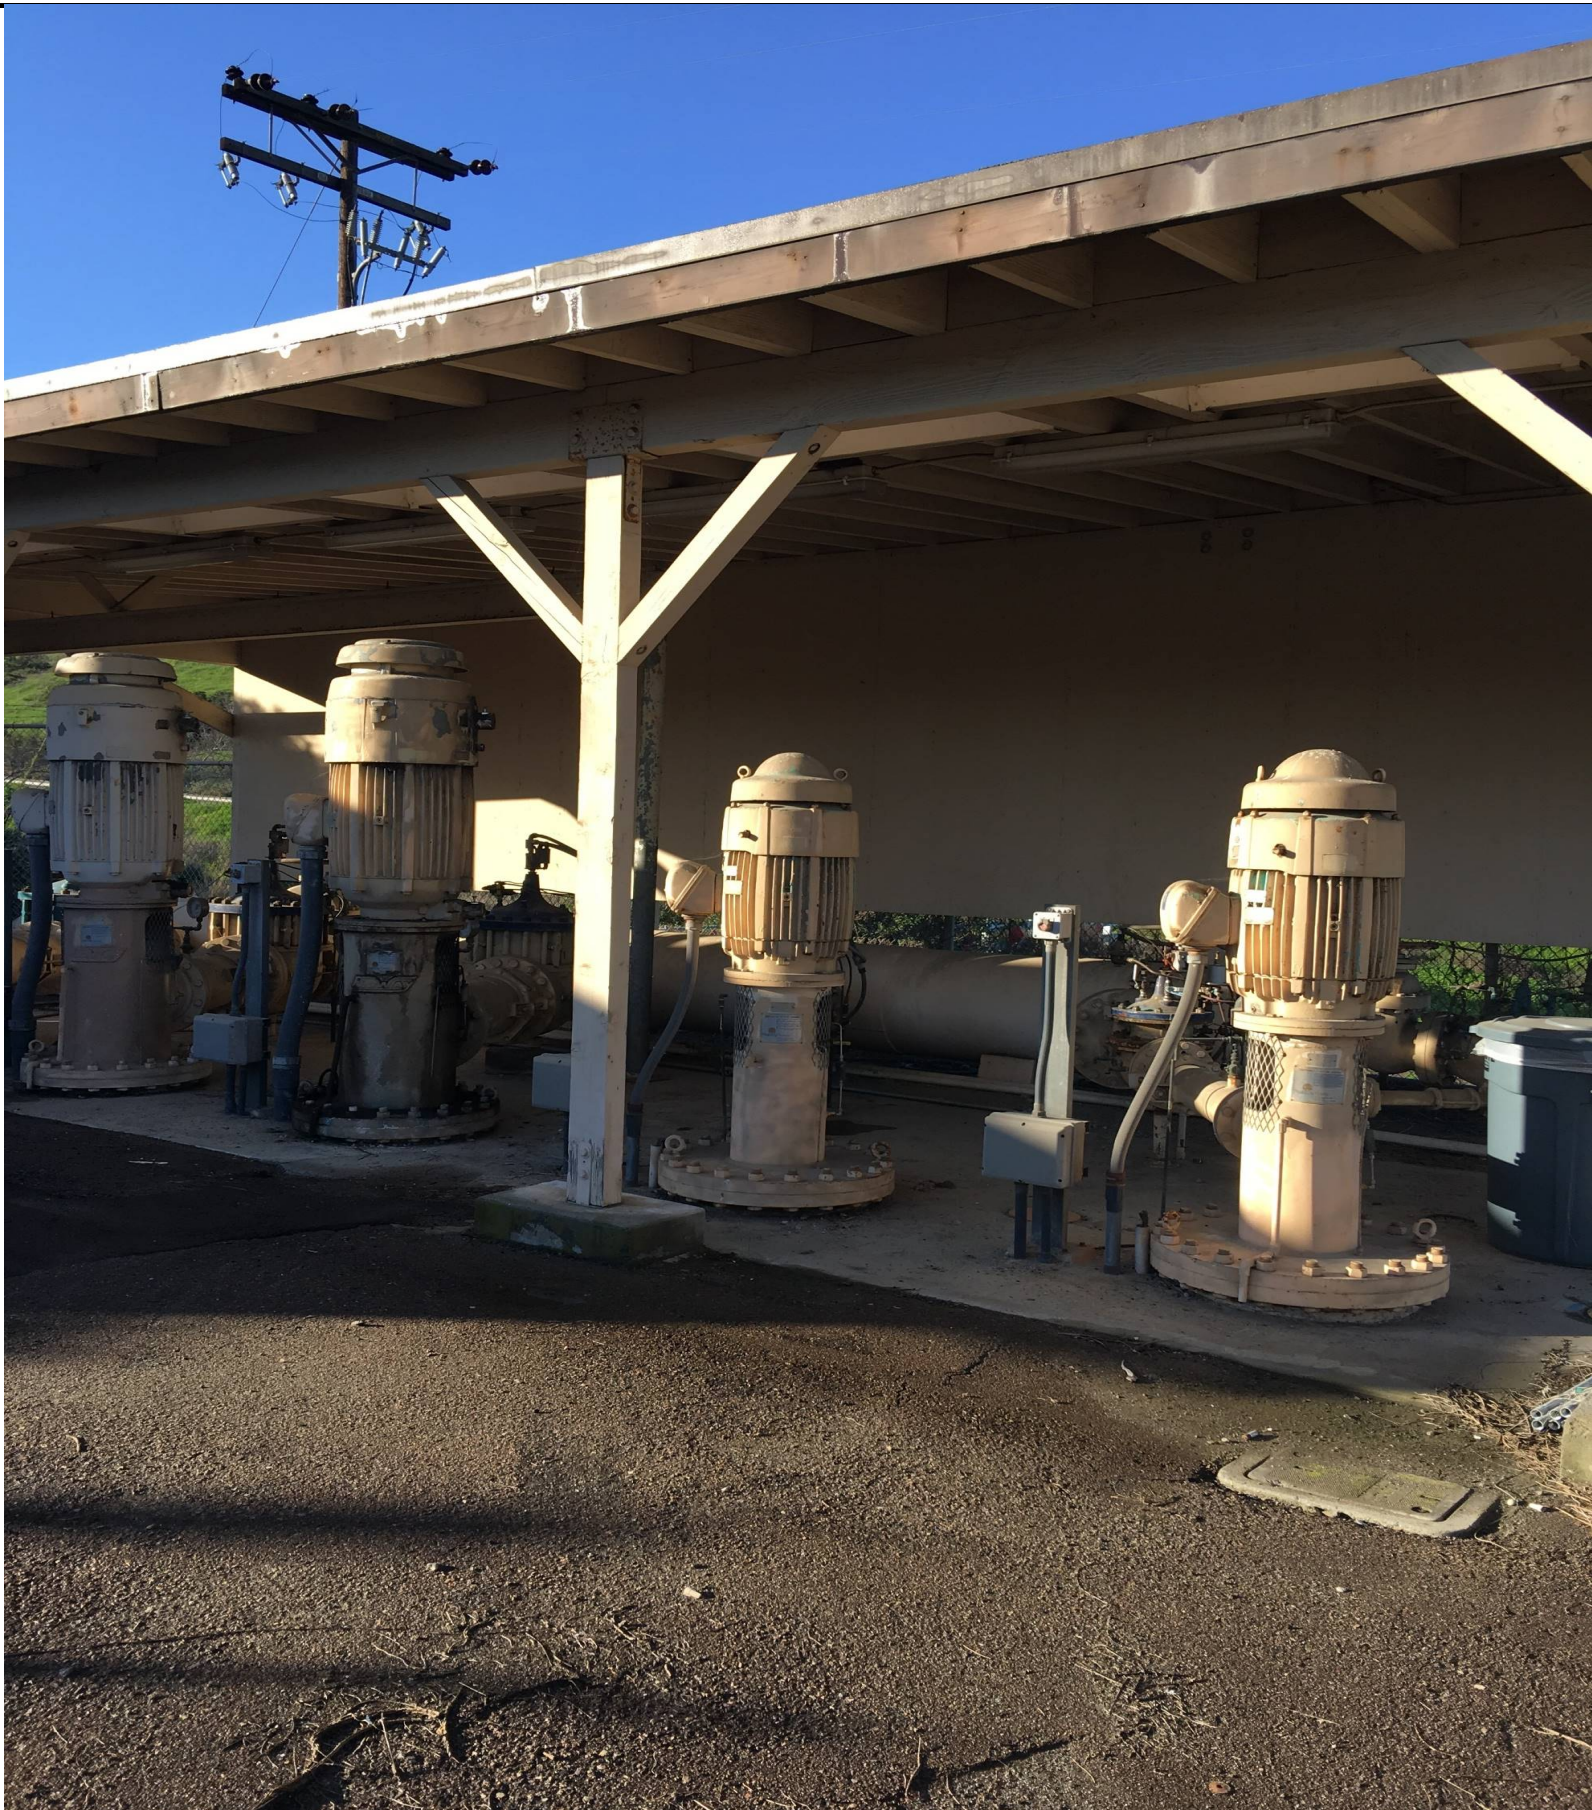
Looking south into pipes and pump structure

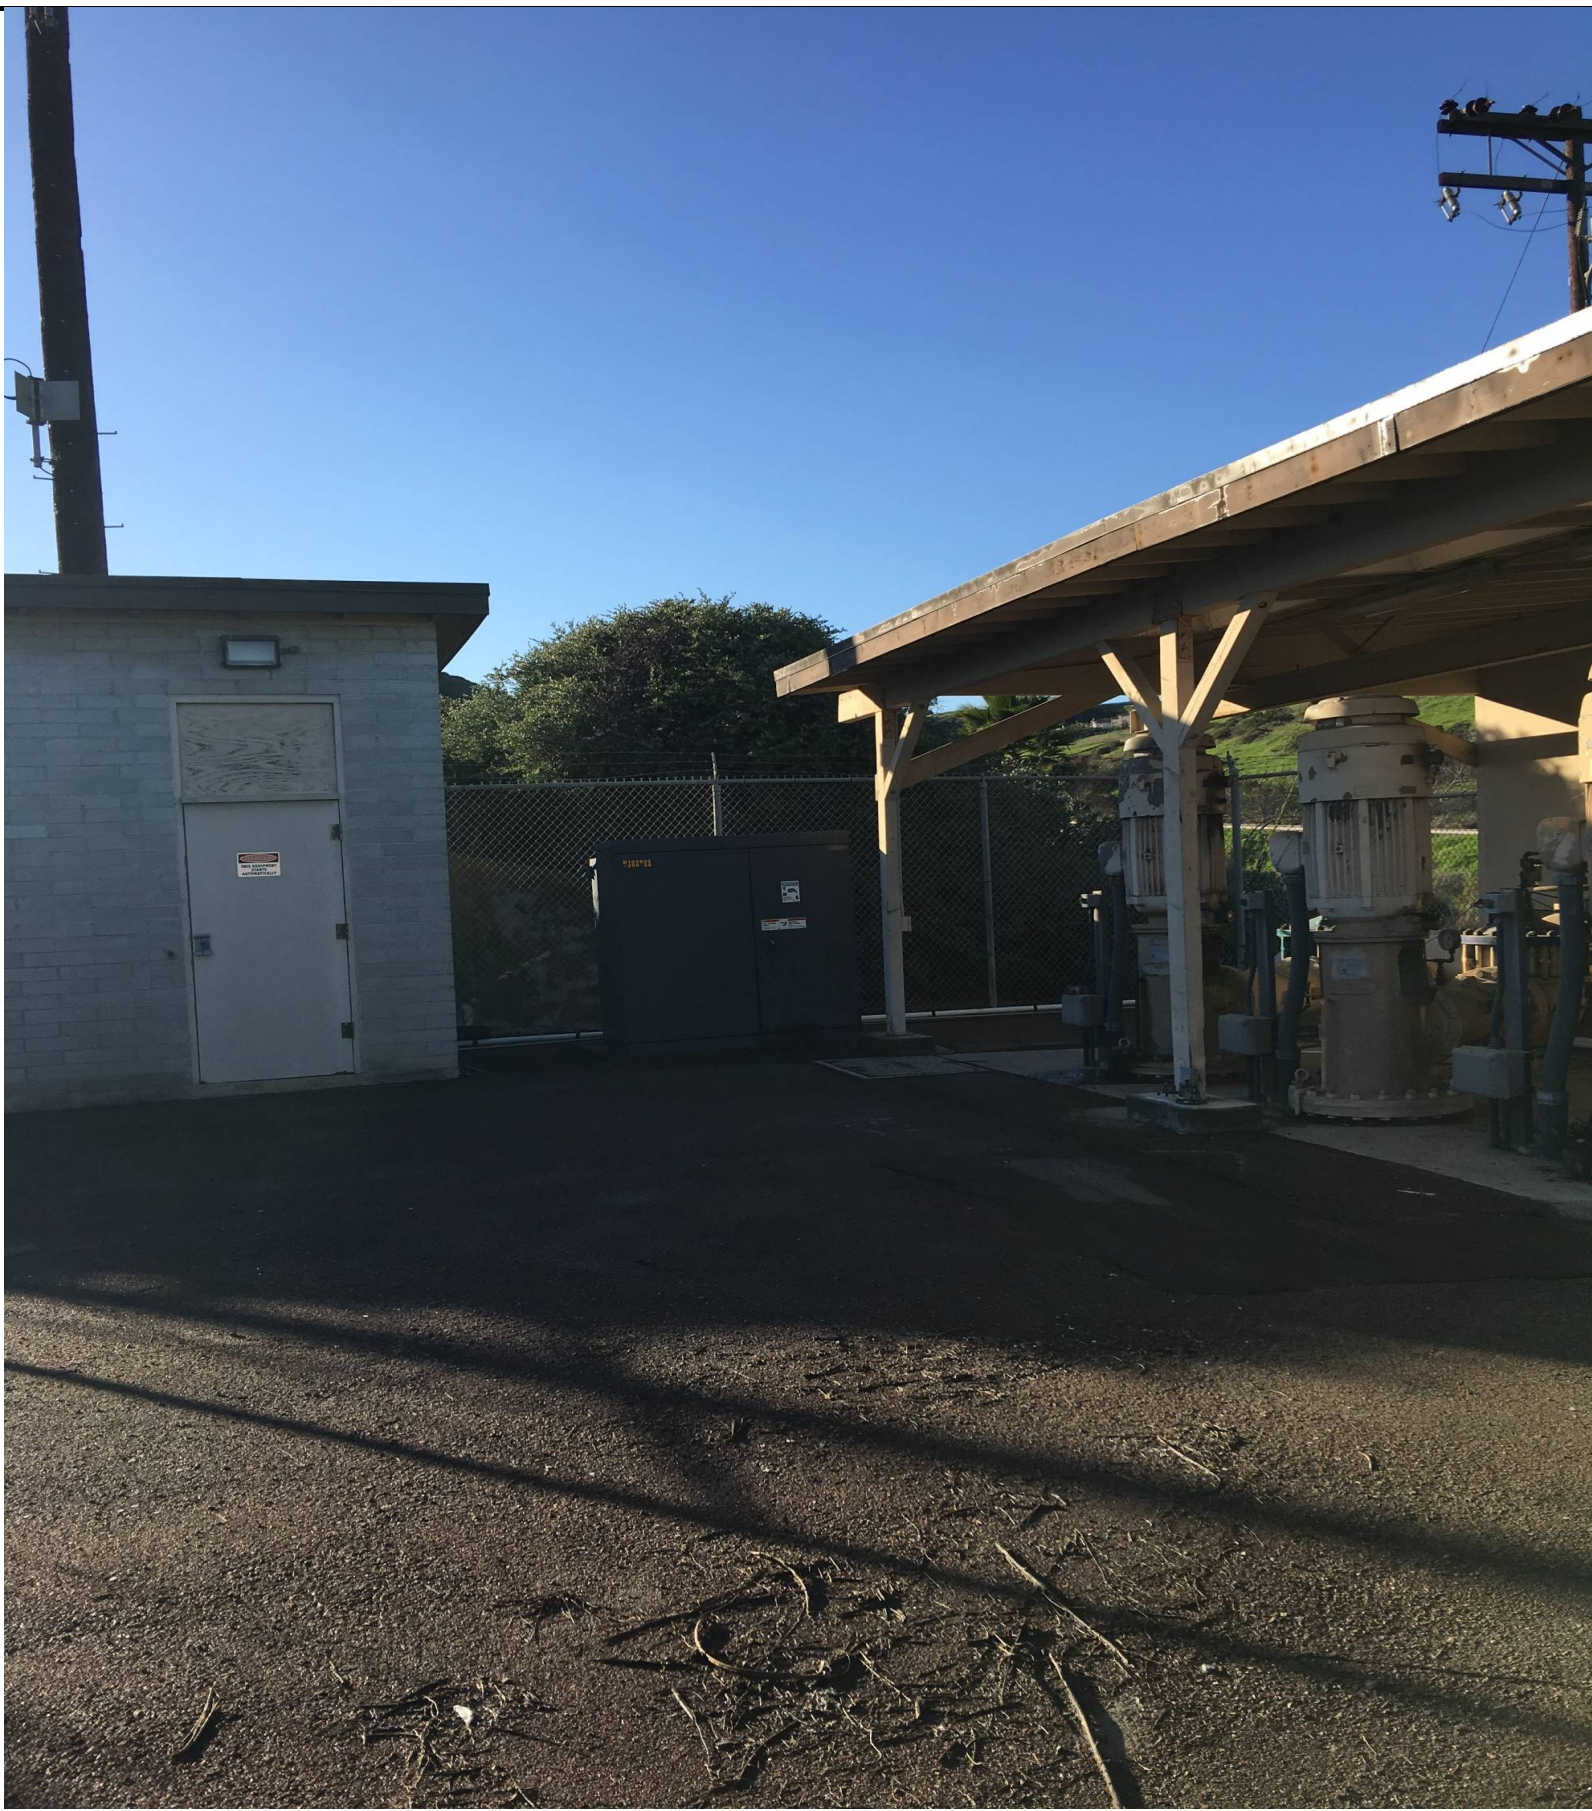
Looking south into pipes and pump structure

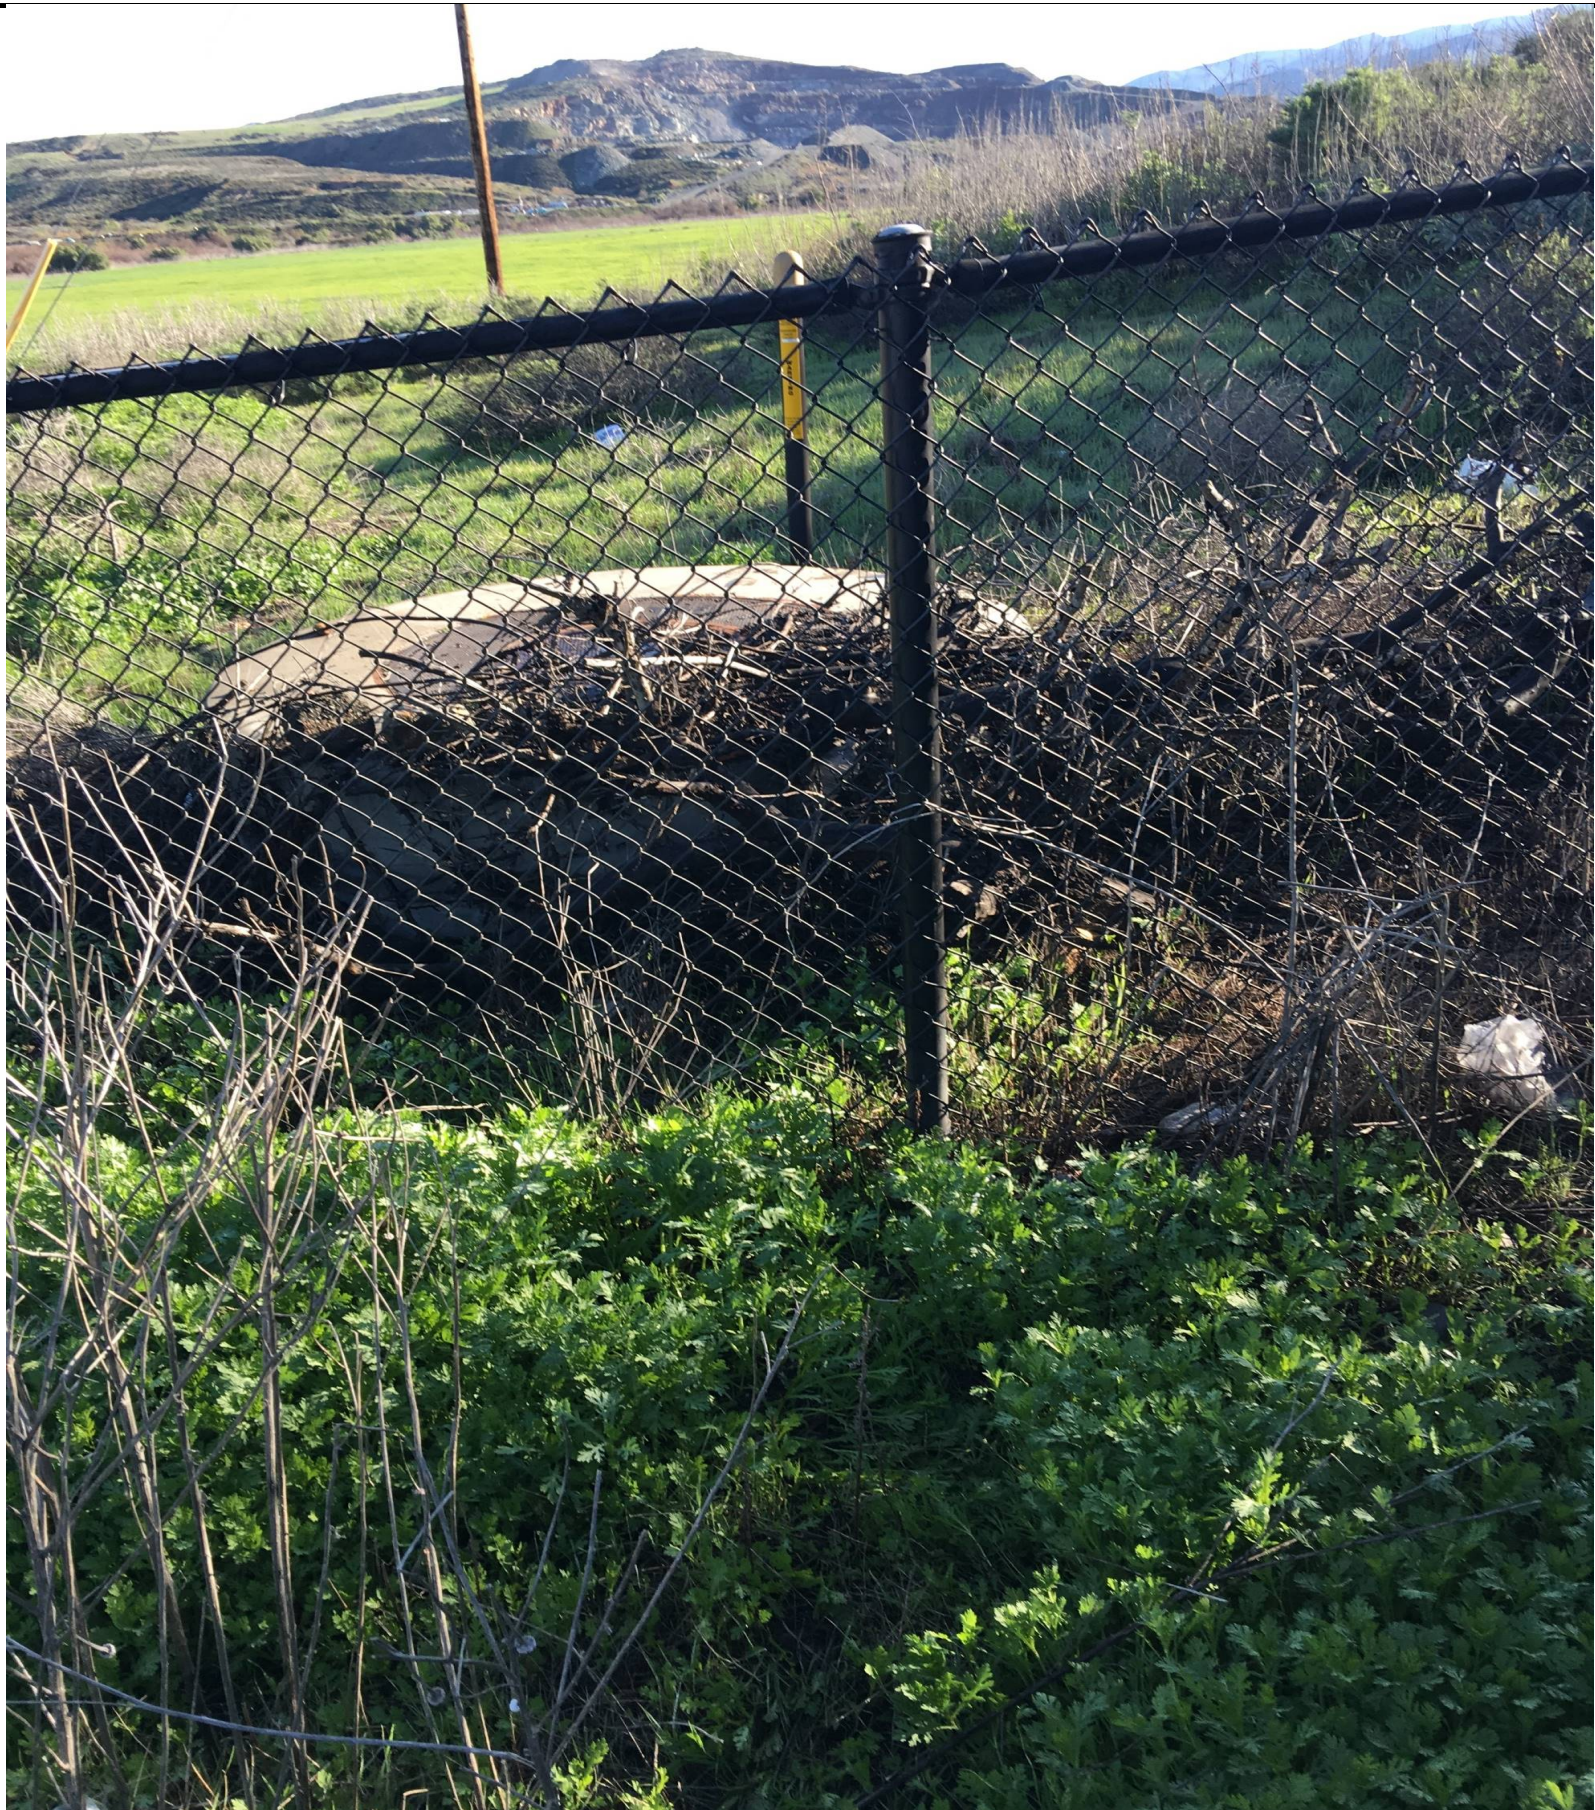
Corrosion protection underground west of Pole 18

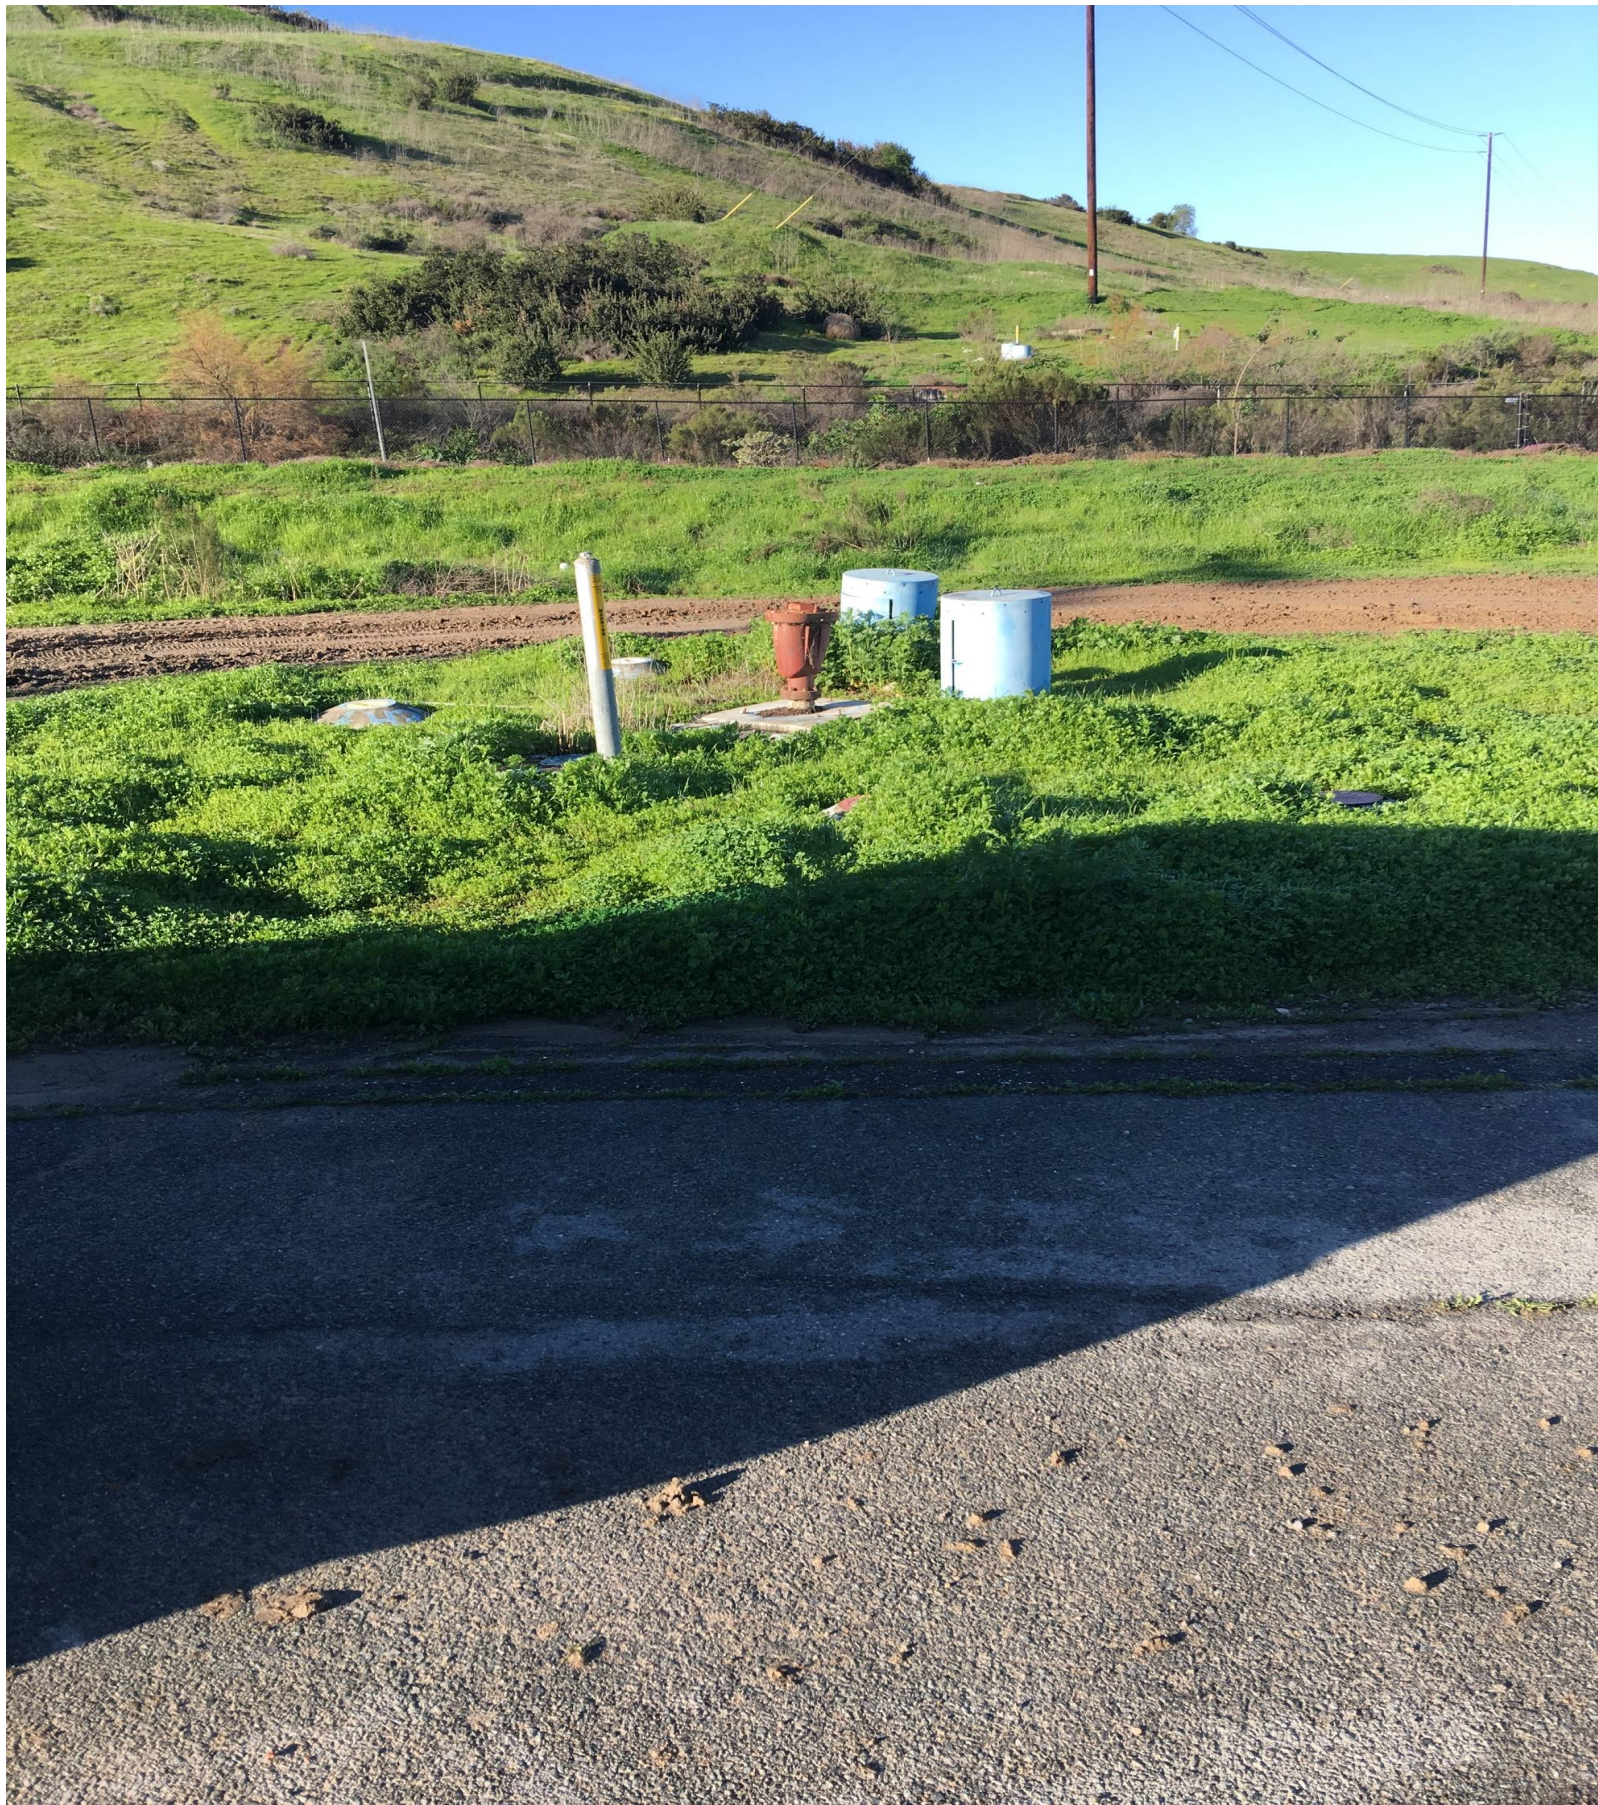
Water line across the street and west of Pole 18
